December 19, 2024
Project No. 2103691

**Re: 2024 Landfill Inspection Report
Caledonia Ash Landfill
We Energies
Town of Caledonia, Racine County, Wisconsin**

CALEDONIA LANDFILL - ANNUAL INSPECTION & CONDITION SUMMARY

Caledonia Ash Landfill Inspection – Photo Log

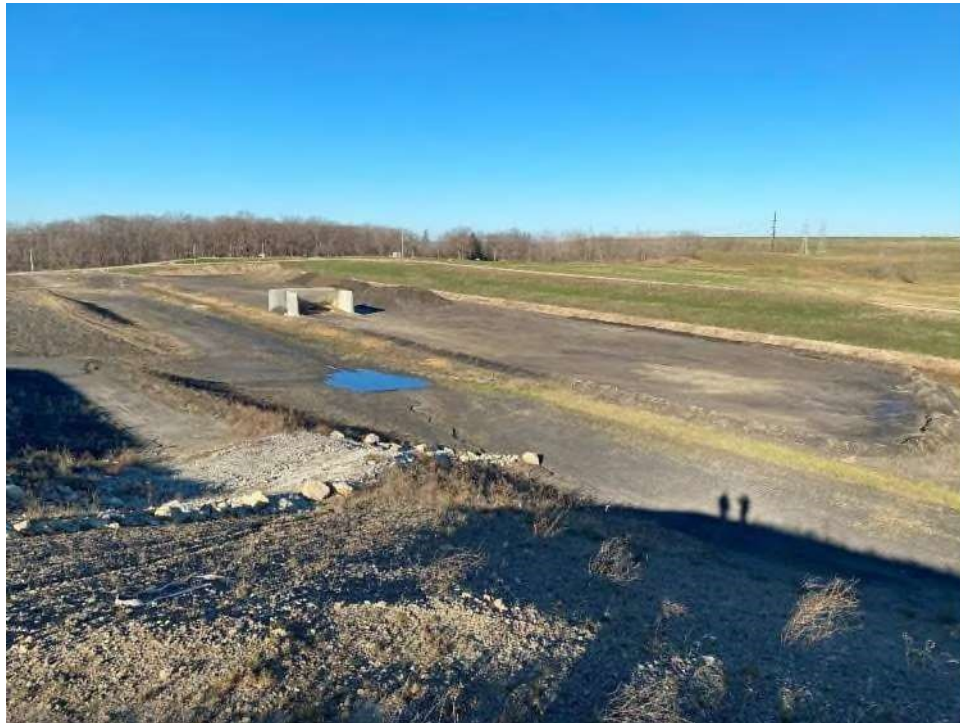
Photo No. 1 – Looking north at active Cells 8 and 10.

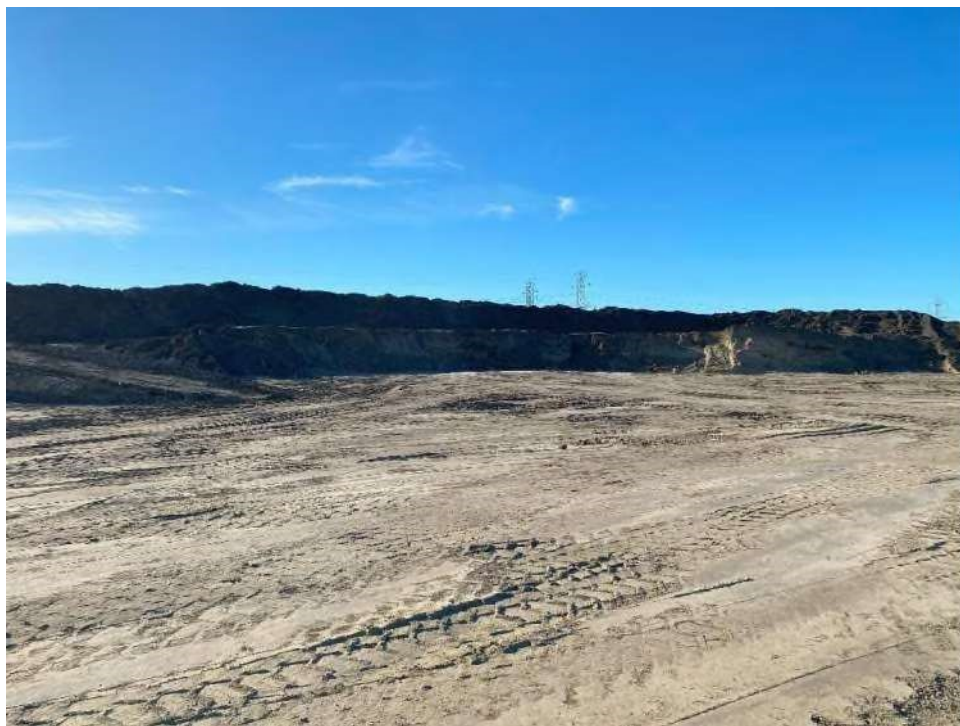
Photo No. 2 – Stockpiled CCR inside Cell 2.

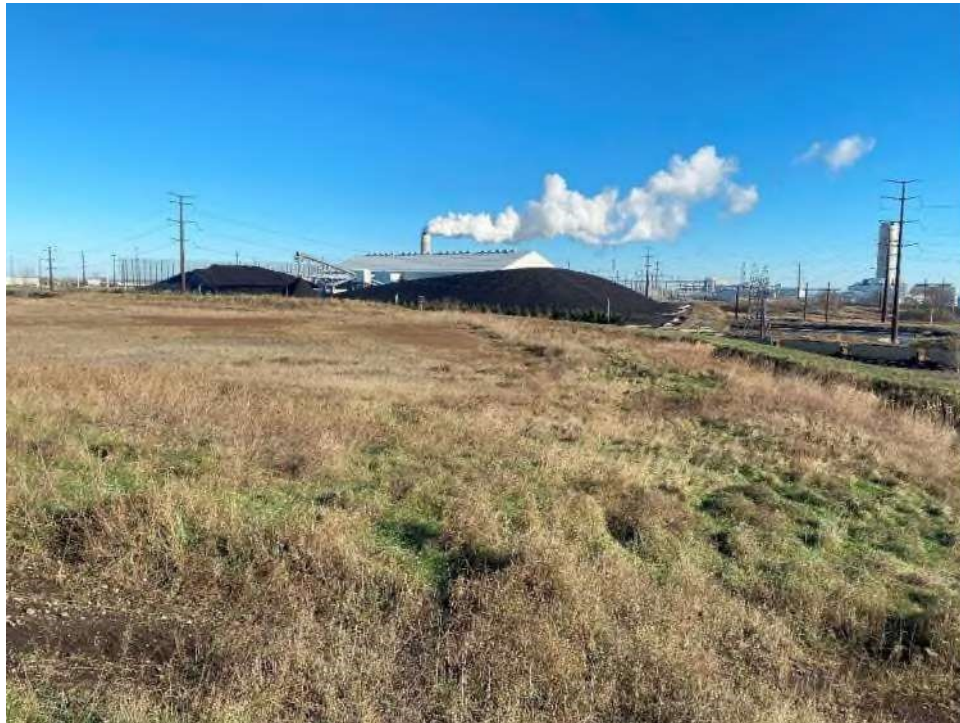
Photo No. 3 – Leachate collection ditch behind Cell 6 and 8 partial cover.

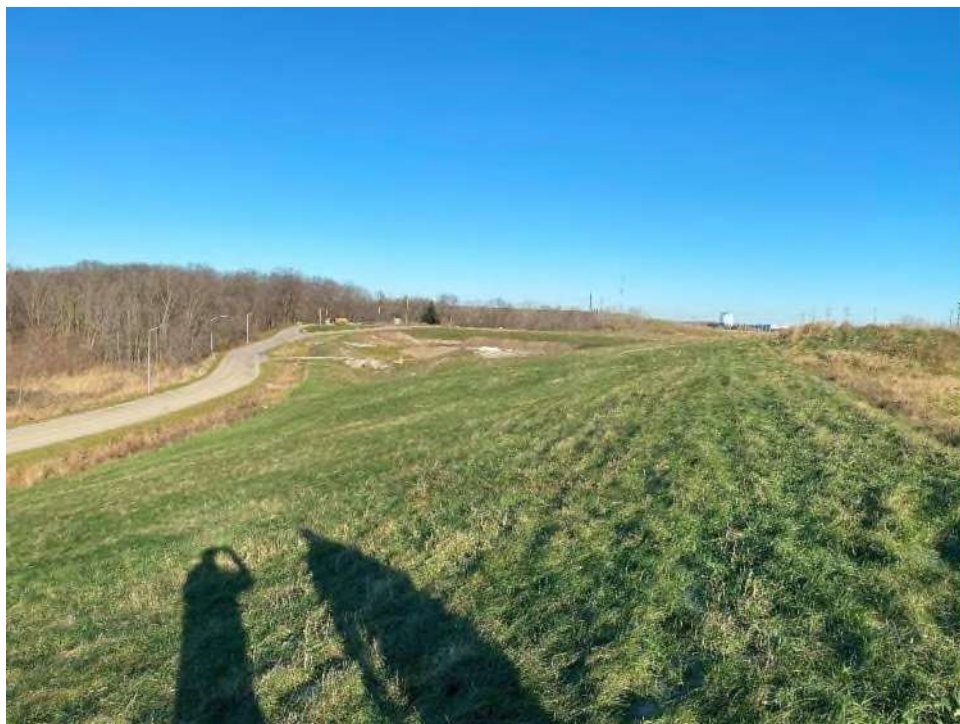
Photo No. 4 – West perimeter berm and stormwater collection ditch, looking north.

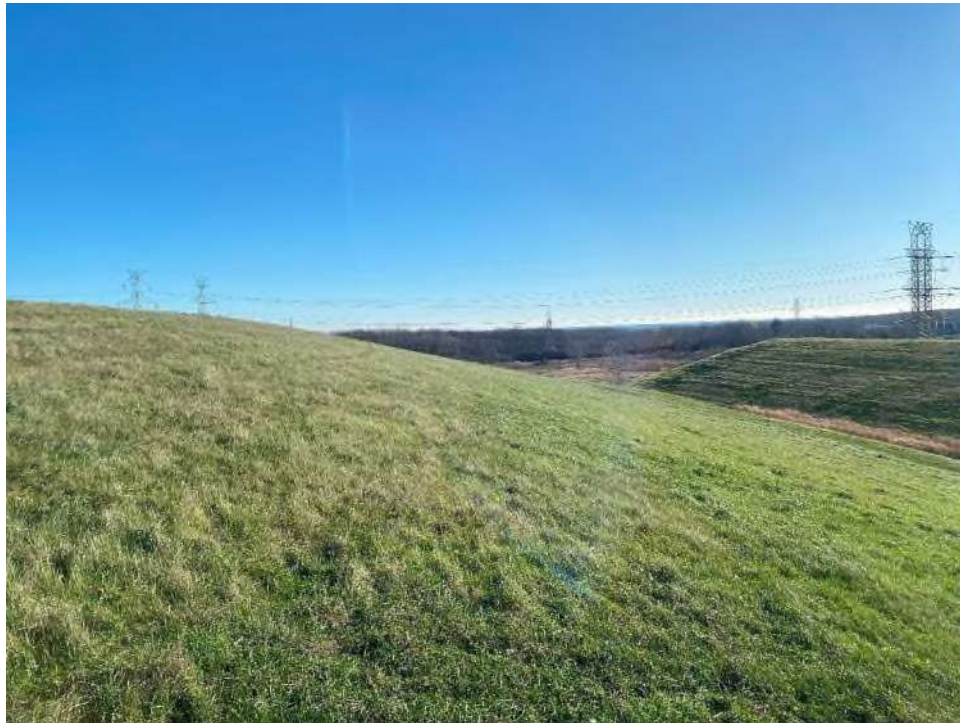
Photo No. 5 – South perimeter berm looking east.

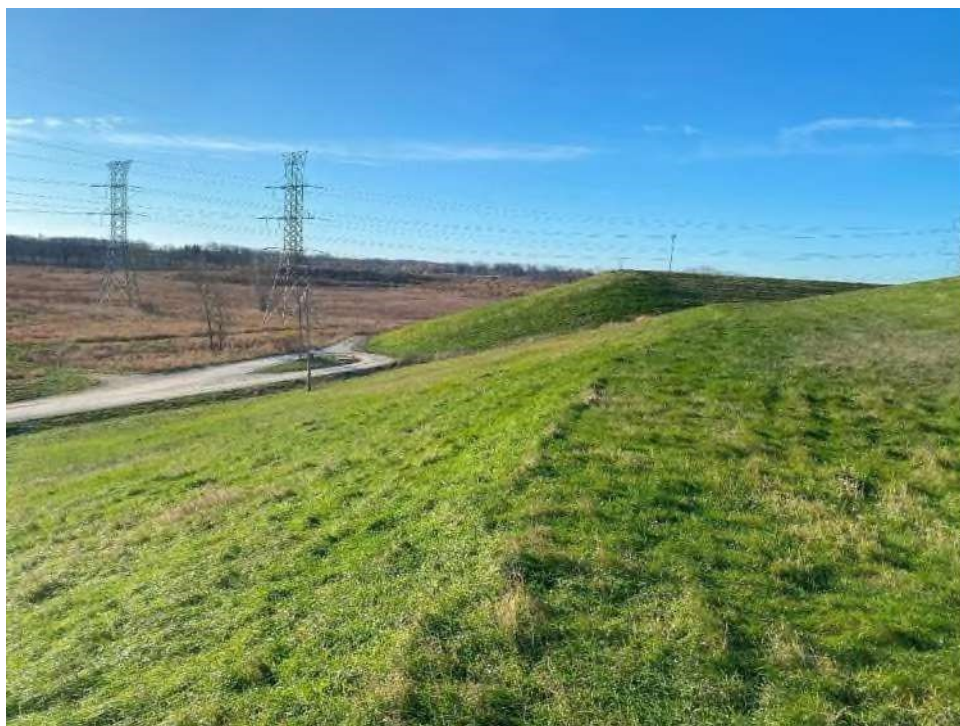
Photo No. 6 – East perimeter berm, looking south.

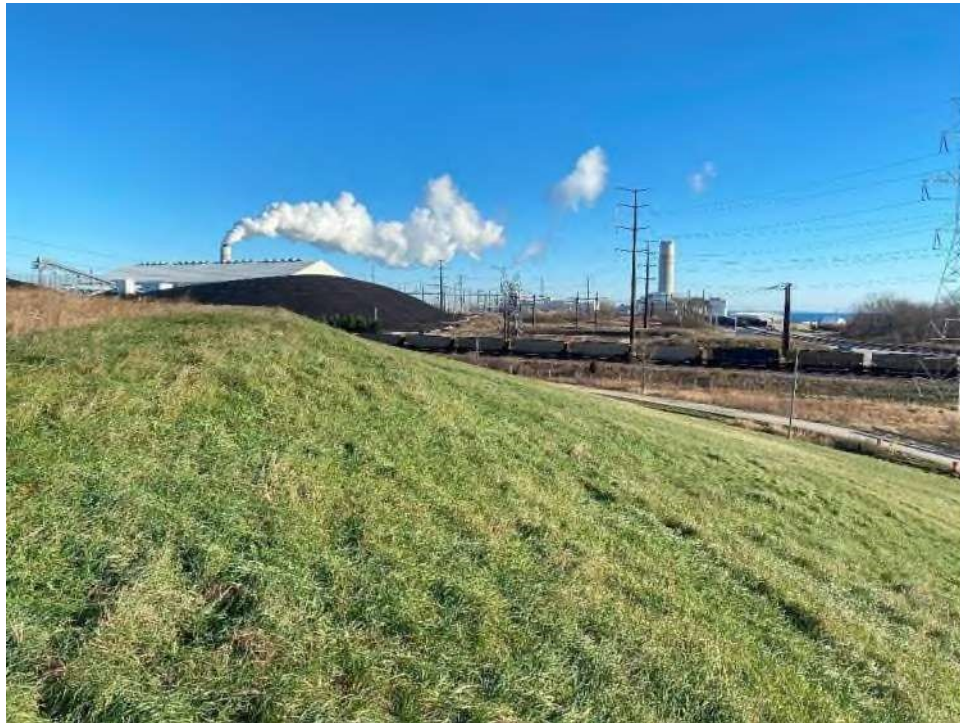
Photo No. 7 – Vegetation on Cell 6 and 8 perimeter slope.

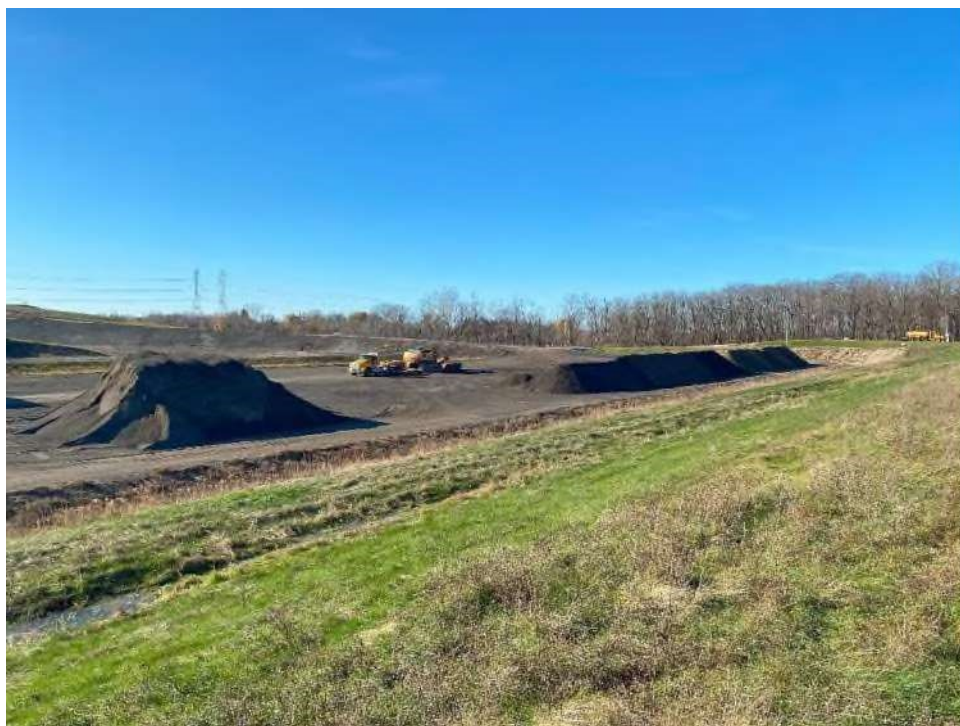
Photo No. 8 – Cell 10 active area. Contractor notified that piles need to be graded and compacted.

Fugitive Dust Control:	In-Cell Stormwater Management	
Tracking Pads :	<input checked="" type="checkbox"/>	Upper Ditch : <input checked="" type="checkbox"/>
Cattle Guards :	<input checked="" type="checkbox"/>	Lower Ditch : <input checked="" type="checkbox"/>
Wheel Wash :	<input checked="" type="checkbox"/>	Down Flume : <input checked="" type="checkbox"/>
Access Road Clean:	<input checked="" type="checkbox"/>	Culverts : <input checked="" type="checkbox"/>
Landfill Surfaces Groomed:	<input checked="" type="checkbox"/>	Reservoirs : <input checked="" type="checkbox"/>
Airbourne Dust Visible:	No	Sediment : Good
Sign of Recent Dust Deposition:	No	Standing Water : No
Comments: Newly placed material on south end of landfill requires grading and compaction. Discussed the status with AW Oakes, they are planning on grading and compacting the newly placed material this afternoon and tomorrow morning.

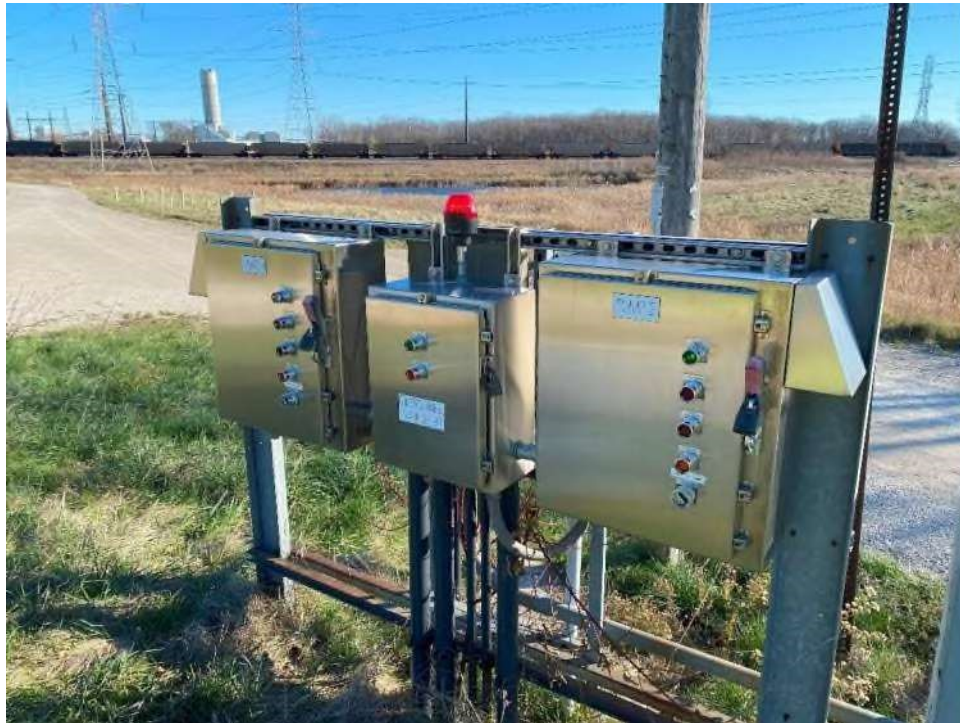
Photo No. 9 – Leachate tank control panel.

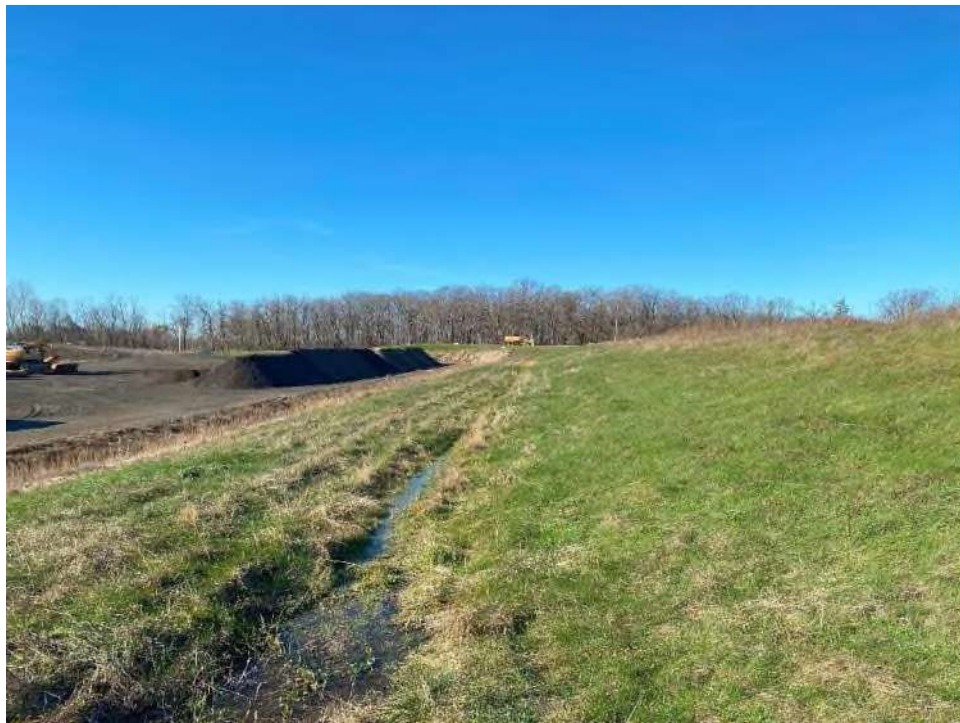
Photo No. 10 – Stormwater ditch north of Cell 10.

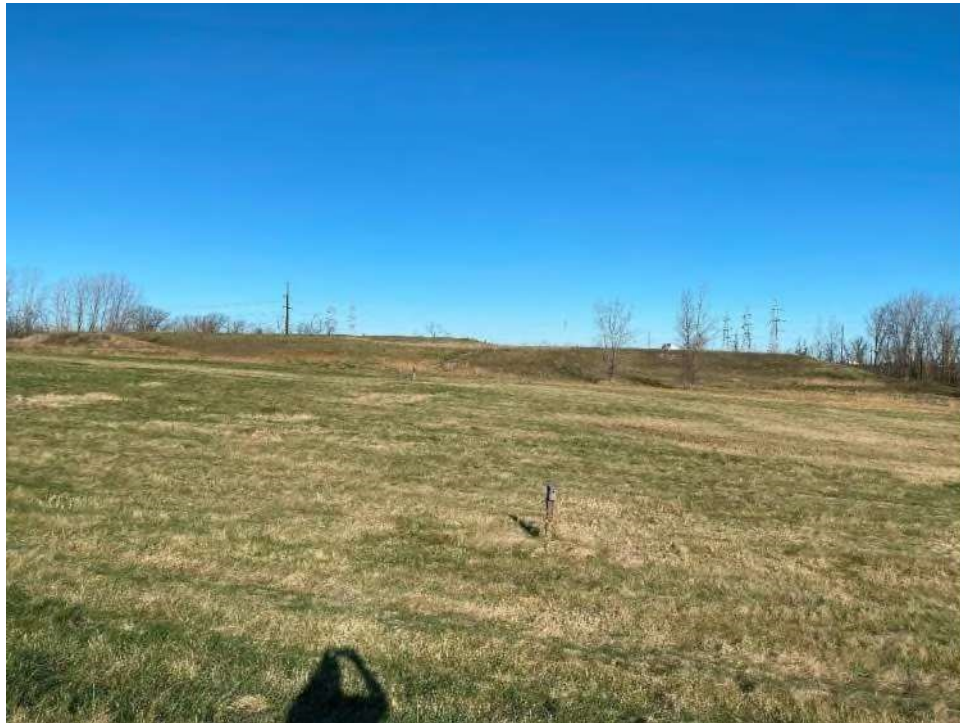
Photo No. 11 – Fully vegetated cover soil stockpile located north of the landfill.
