December 19, 2024
Project No. 2103683

**Re: 2024 Landfill Inspection Report
Pleasant Prairie Power Plant Ash Landfill
We Energies
Pleasant Prairie, Kenosha County, Wisconsin**

2024 Landfill Inspection Report
Pleasant Prairie Power Plant Ash Landfill
We Energies
Pleasant Prairie, Kenosha County, Wisconsin
December 19, 2024

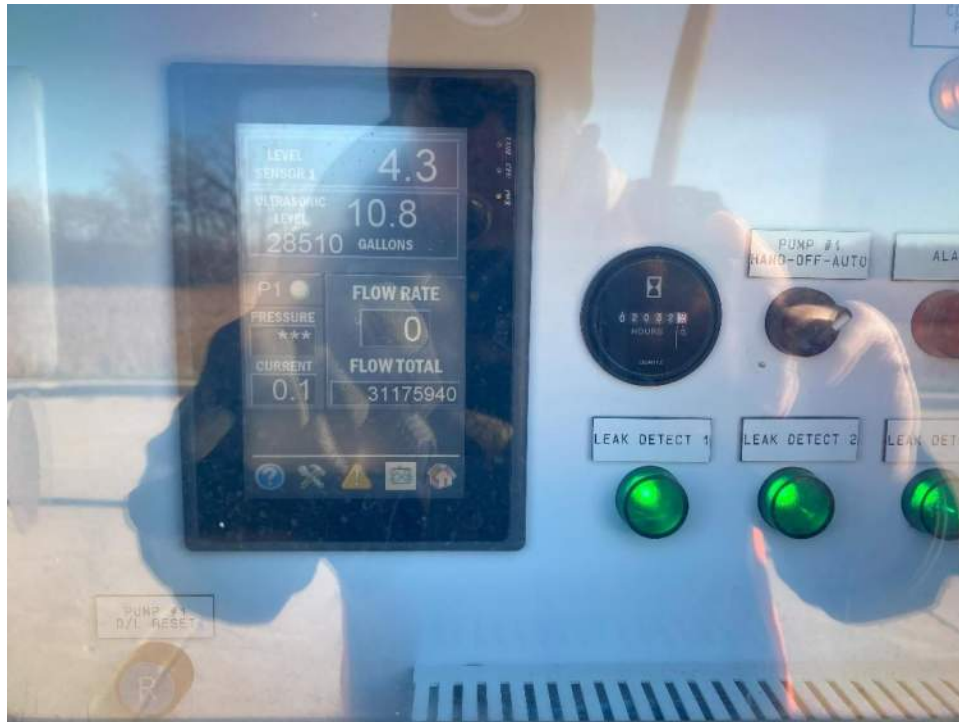
Photo No. 1 – Leachate loadout screen.

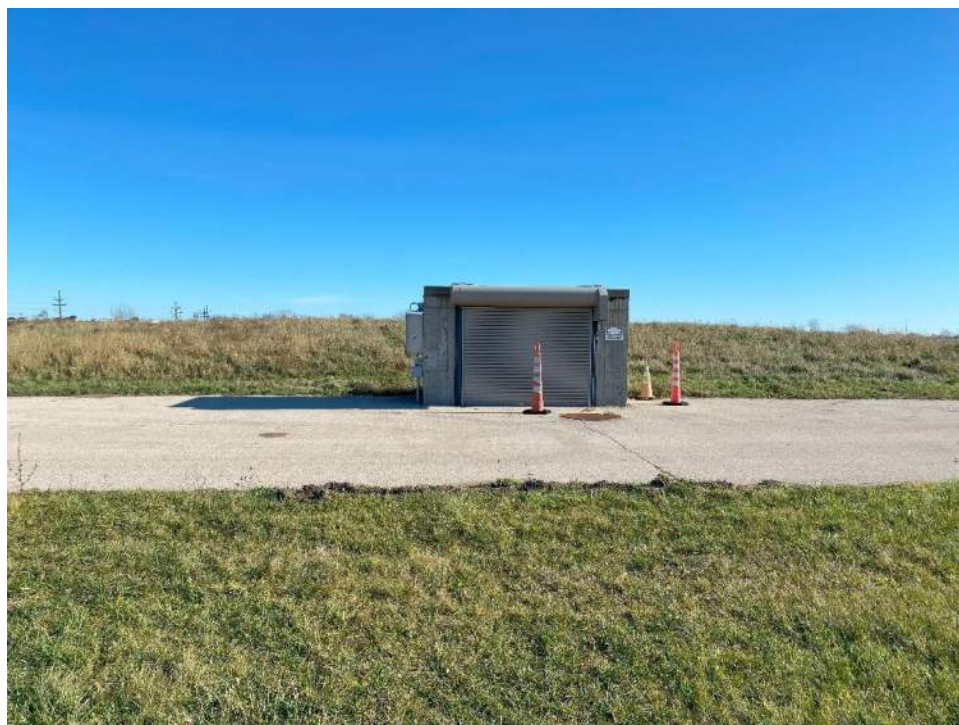
Photo No. 2 – Leachate sump collection vault.

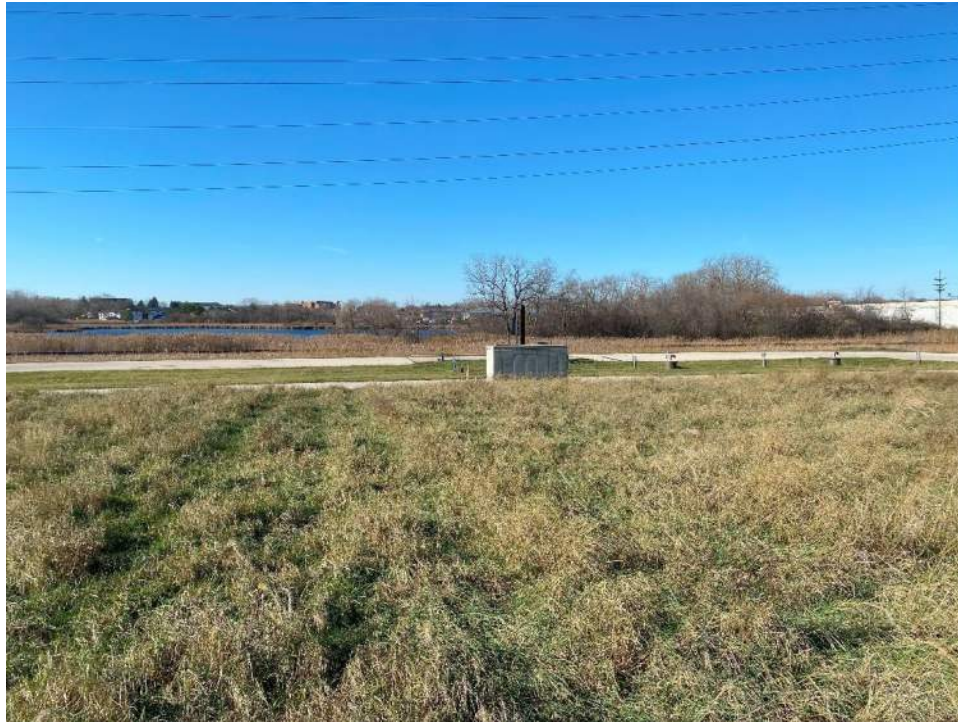
Photo No. 3 – Looking west from the Cell 1 cover at the leachate loadout pad.

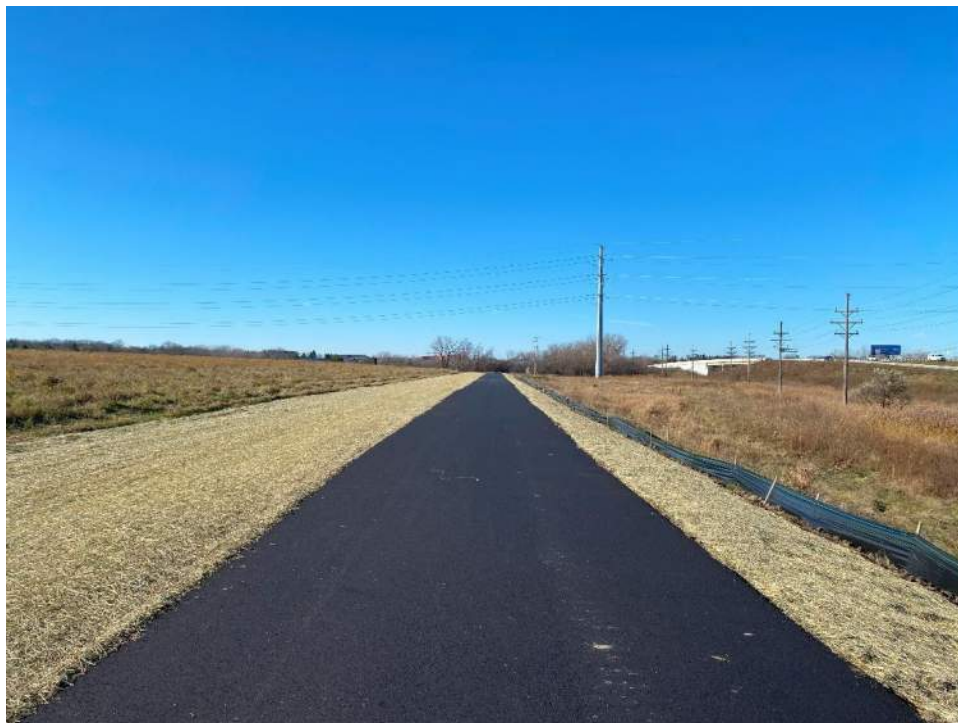
Photo No. 4 – North slope of Cell 1, looking west. Asphalt perimeter road was installed in 2024.

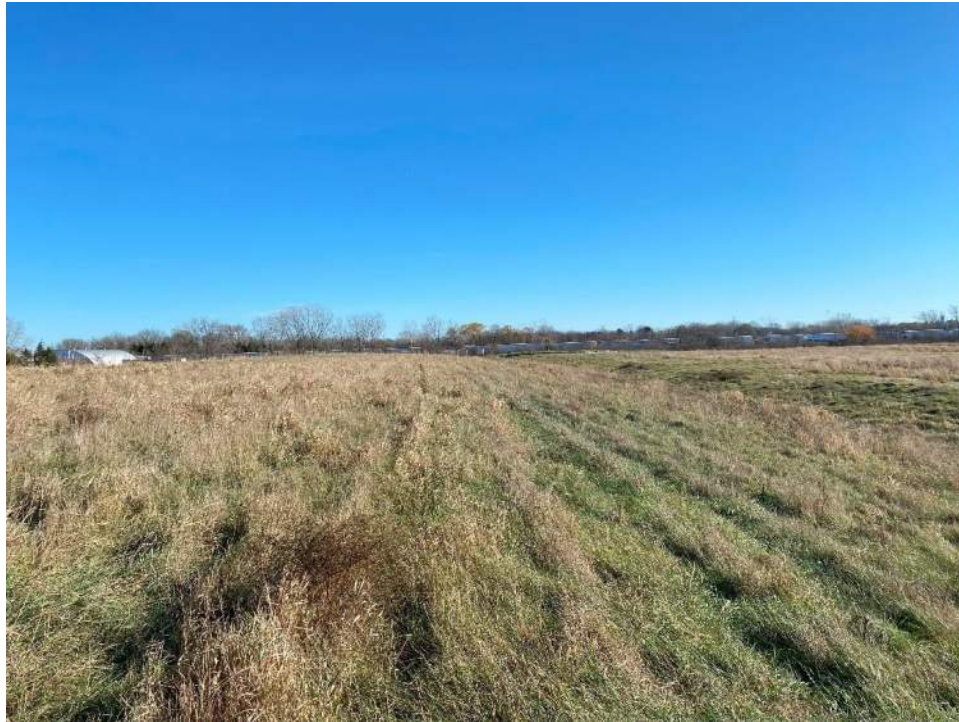
Photo No. 5 – South slope of Cell 1 and perimeter stormwater ditch, looking east.

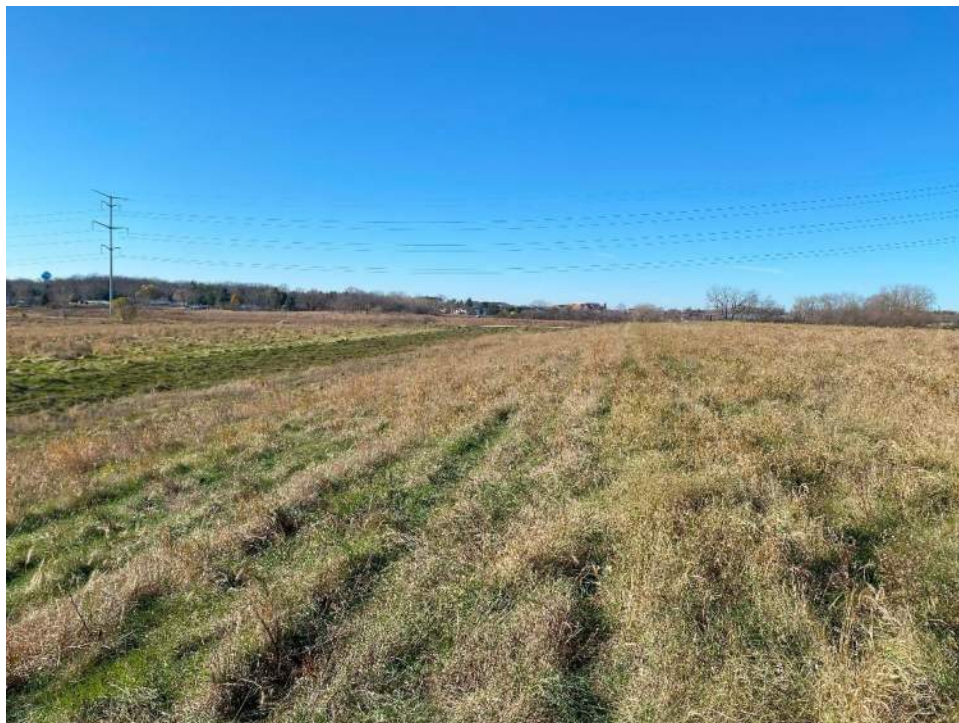
Photo No. 6 – South slope of Cell 1 and perimeter stormwater ditch, looking west.

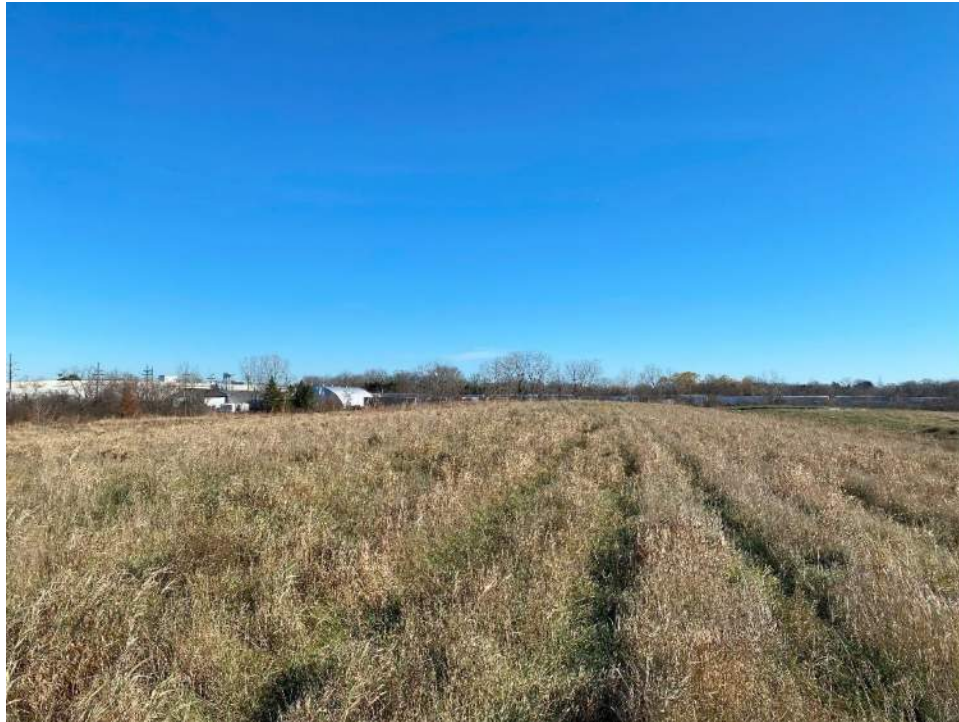
Photo No. 7 – Top of Cell 1 cover, looking east.

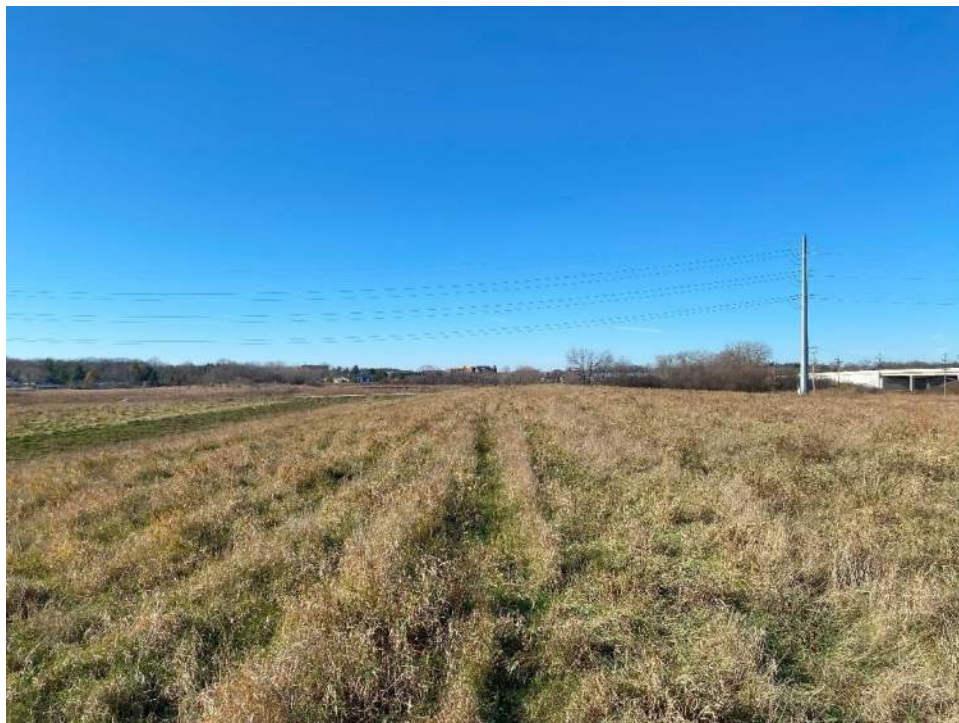
Photo No. 8 – Top of Cell 1 cover, looking northwest.

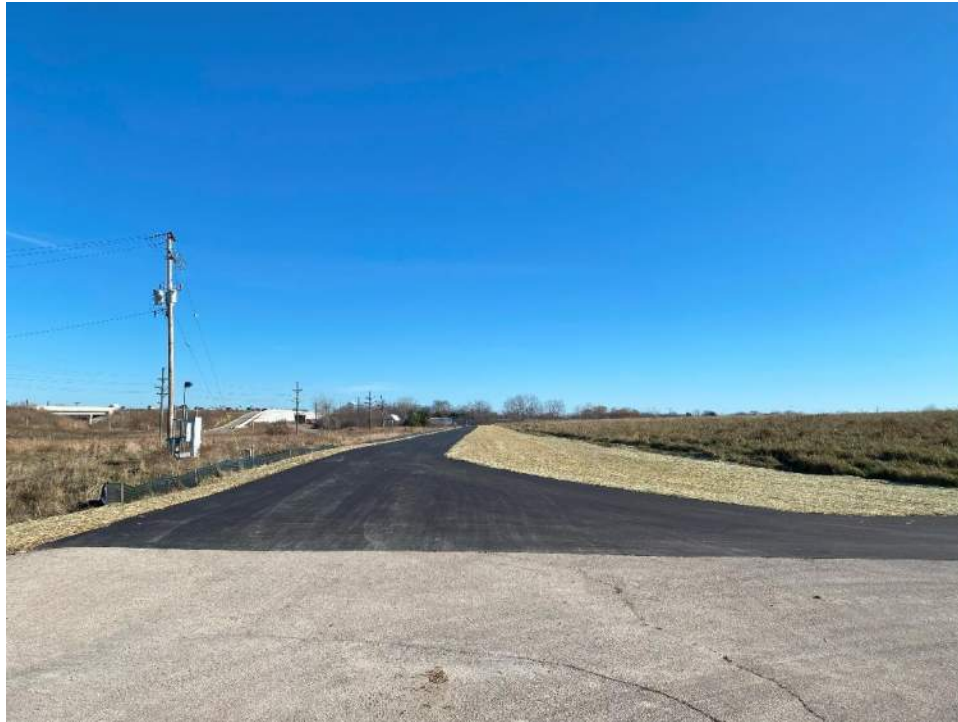
Photo No. 9 – Southwest corner of Cell 1 cover, looking east.

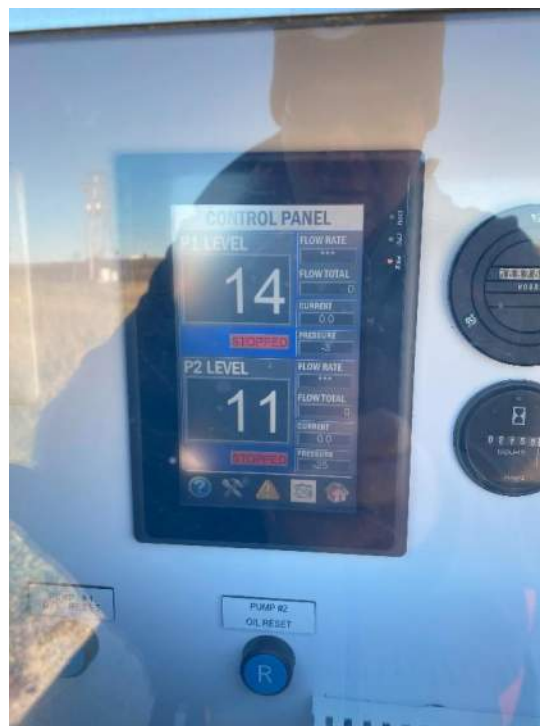
Photo No. 10 – Leachate loadout screen.
