**Re: 2024 Landfill Inspection Report
Presque Isle Power Plant Ash Landfill No. 3
We Energies
Marquette Township, Michigan**

2024 Landfill Inspection Report
Presque Isle Power Plant Ash Landfill No. 3
We Energies
Marquette Township, Michigan
December 19, 2024

Presque Isle Power Plant Ash Landfill No. 3 Inspection – Photo Log

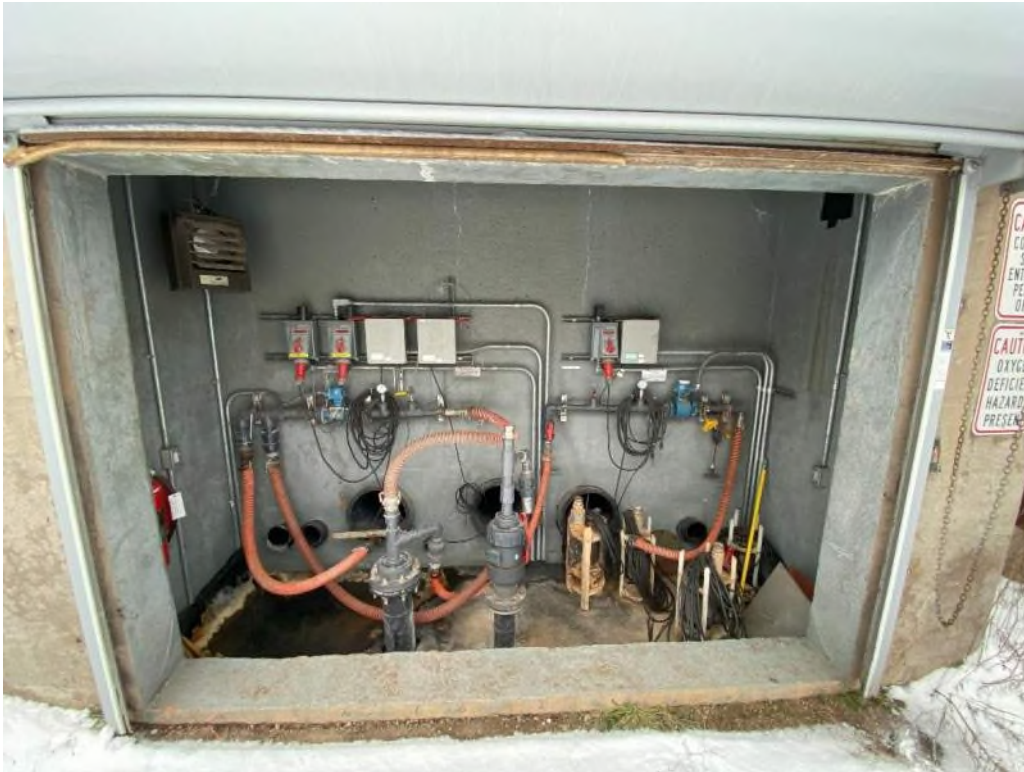
Photo No. 1 – Landfill No. 3, Cell 2 leachate collection riser vault.

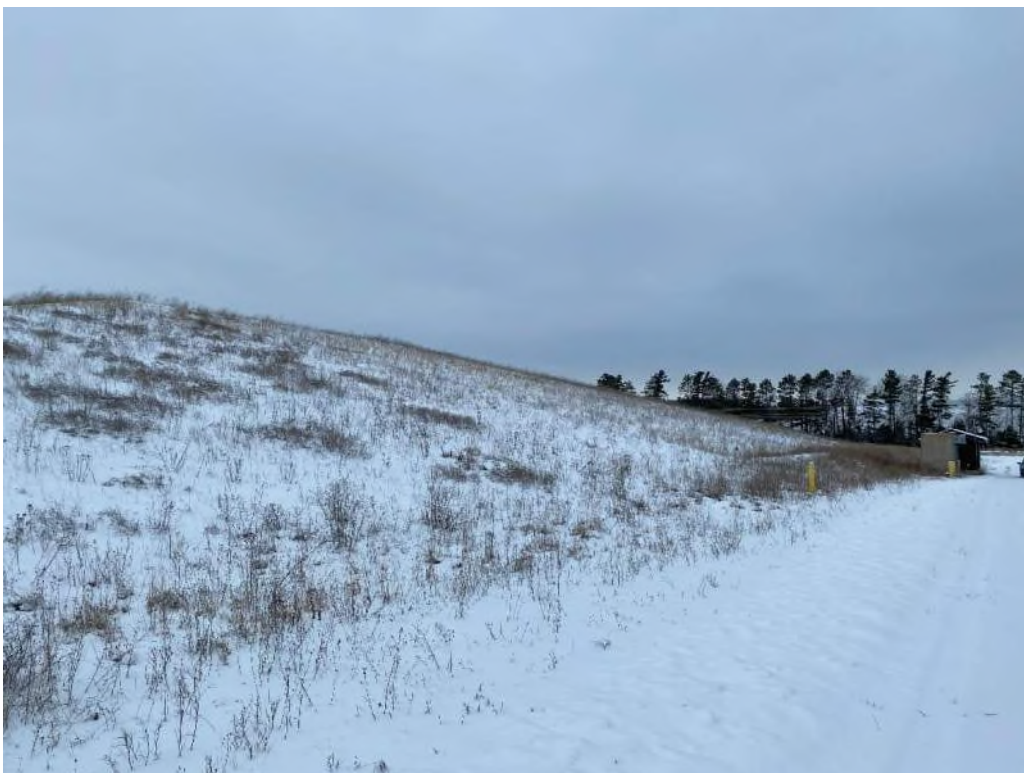
Photo No. 2 – East slope of Landfill No. 3, looking northwest

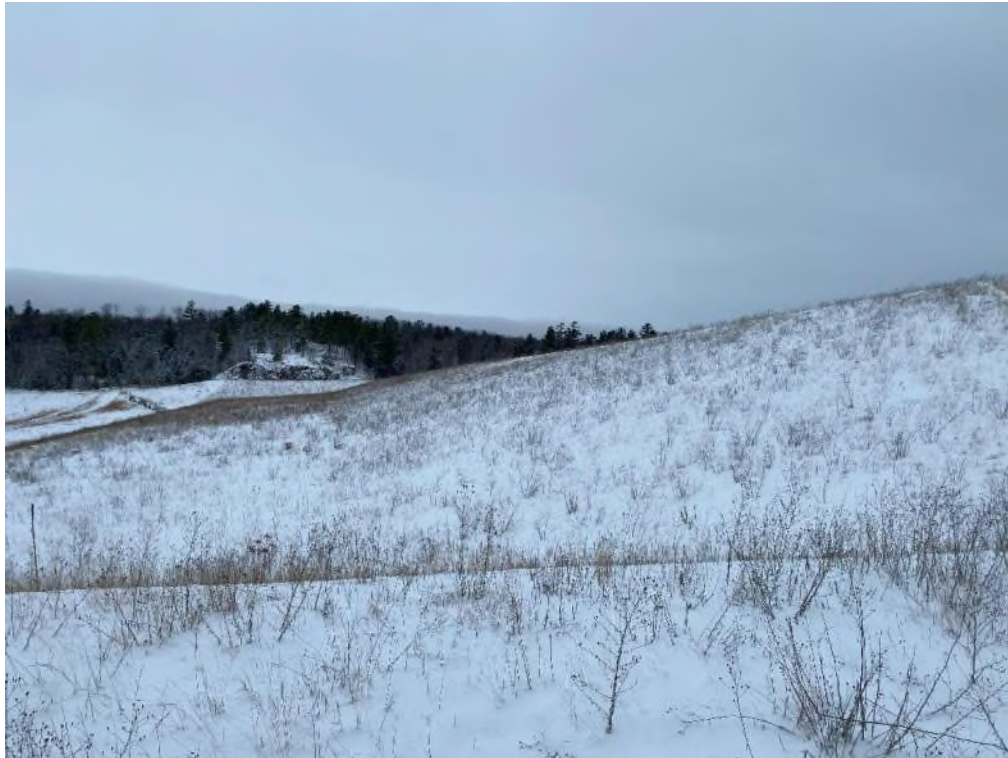
Photo No. 3 – South slope of Landfill No. 3, looking west.

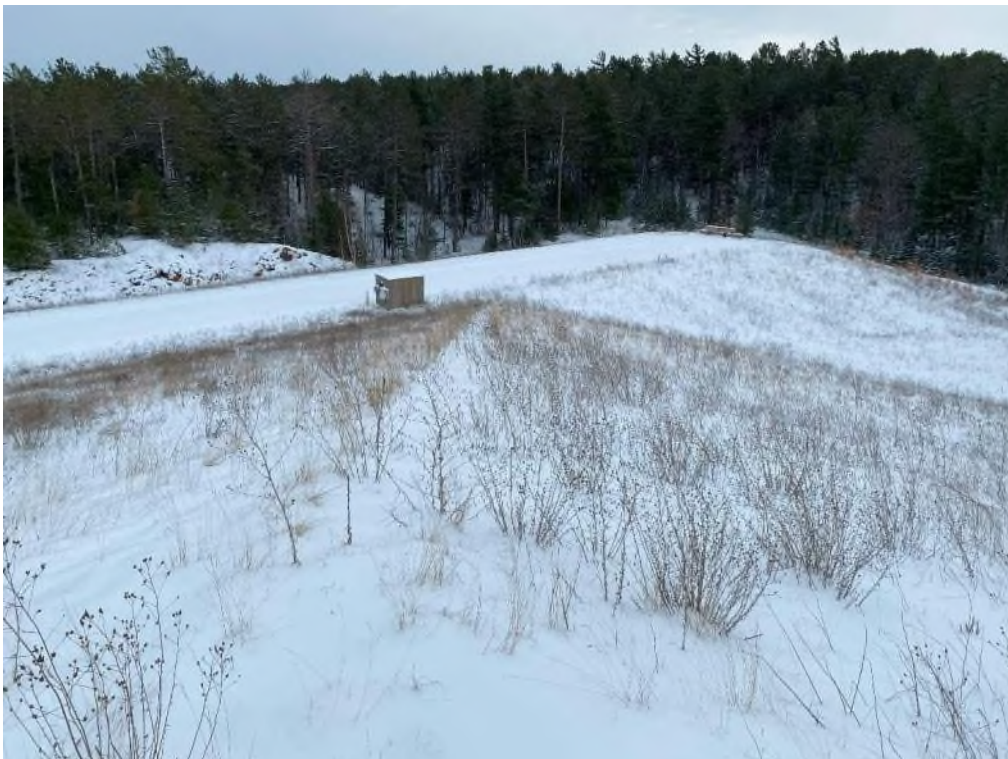
Photo No. 4 – Landfill No. 3 east and south slope and riser vault building.

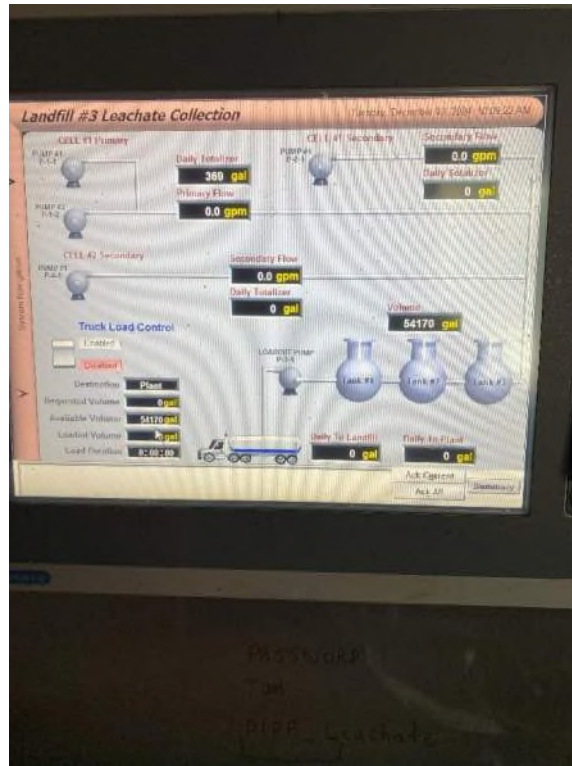
Photo No. 5 – Landfill No. 3 leachate loadout facility screen.

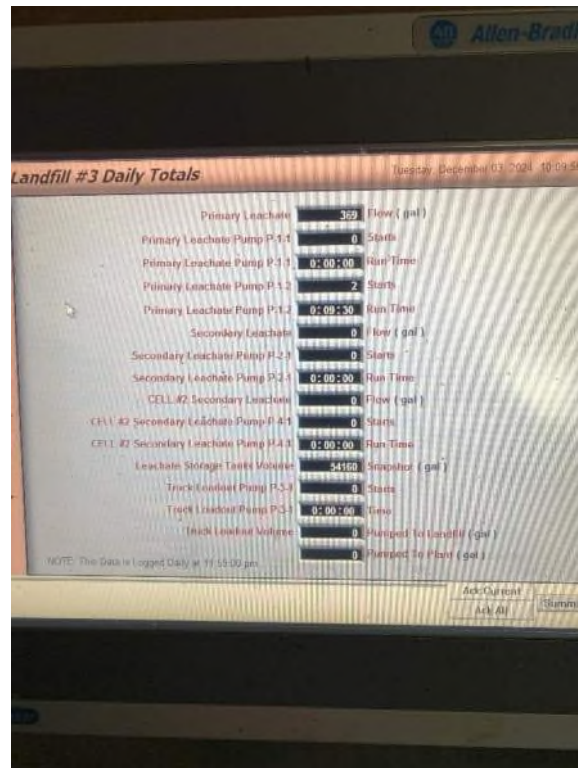
Photo No. 6 – Landfill No. 3 leachate loadout facility screen.

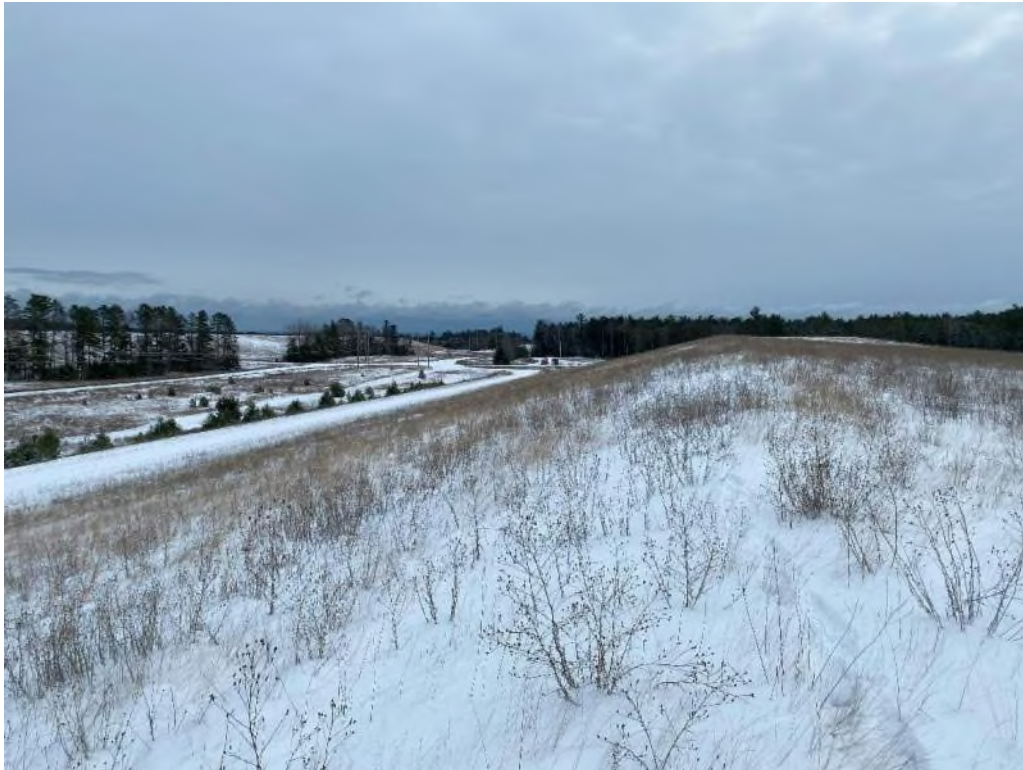
Photo No. 7 – North slope of Landfill No. 3, looking east.

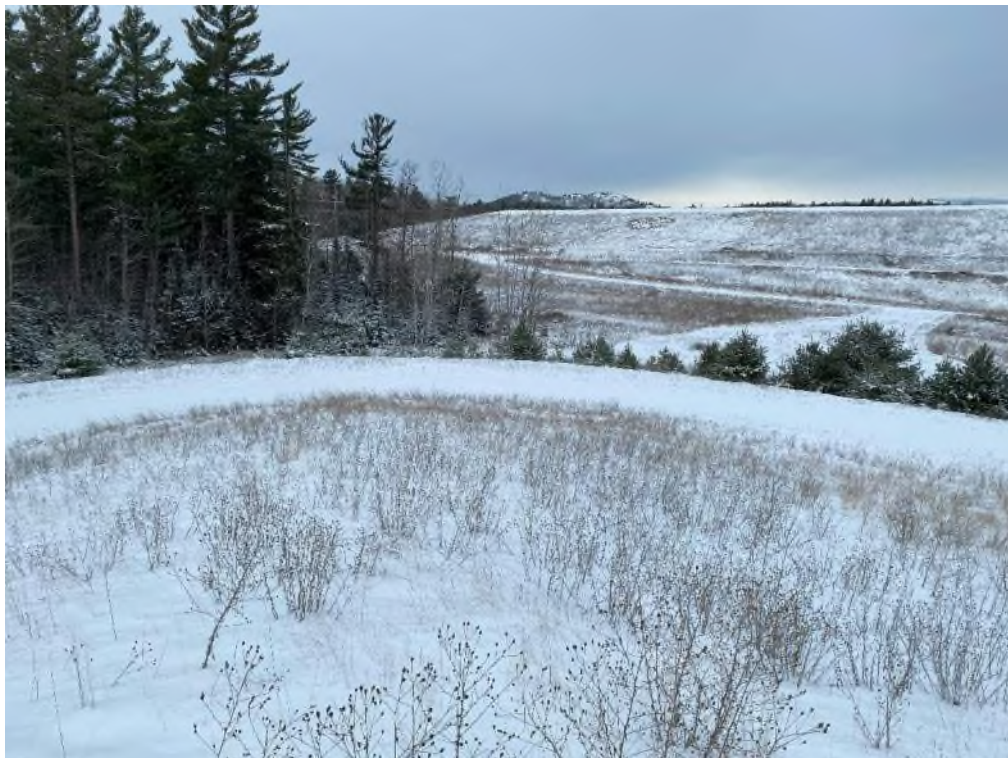
Photo No. 8 – Northwest corner of Landfill No. 3.

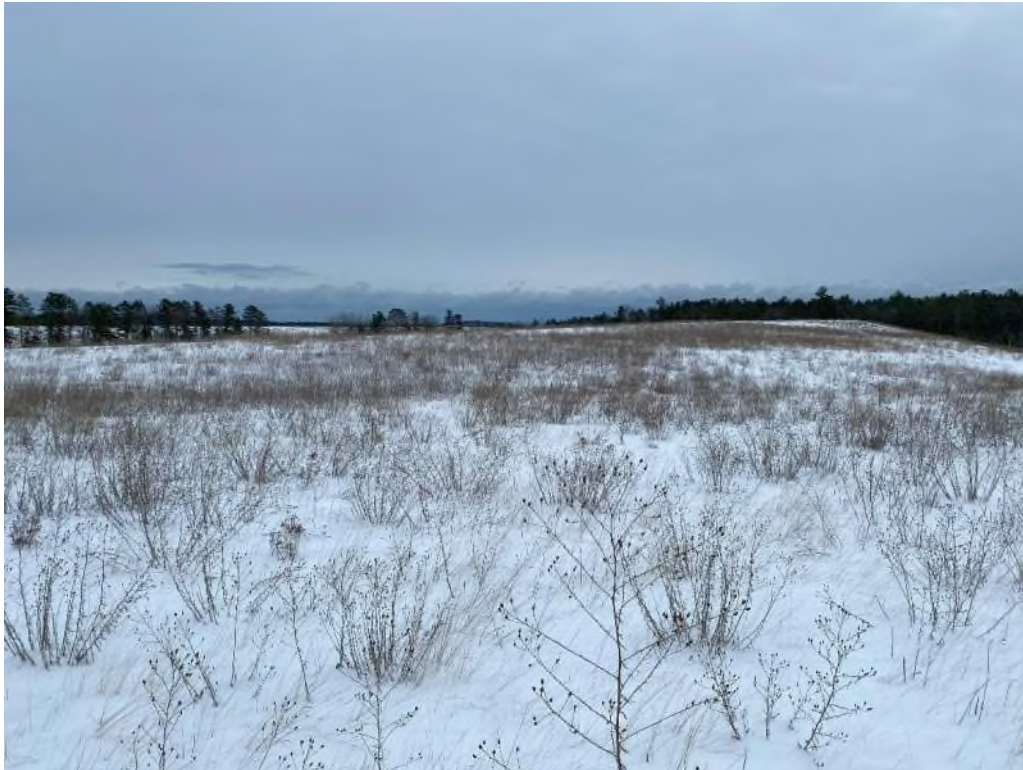
Photo No. 9 – Top of Landfill No. 3, looking east.

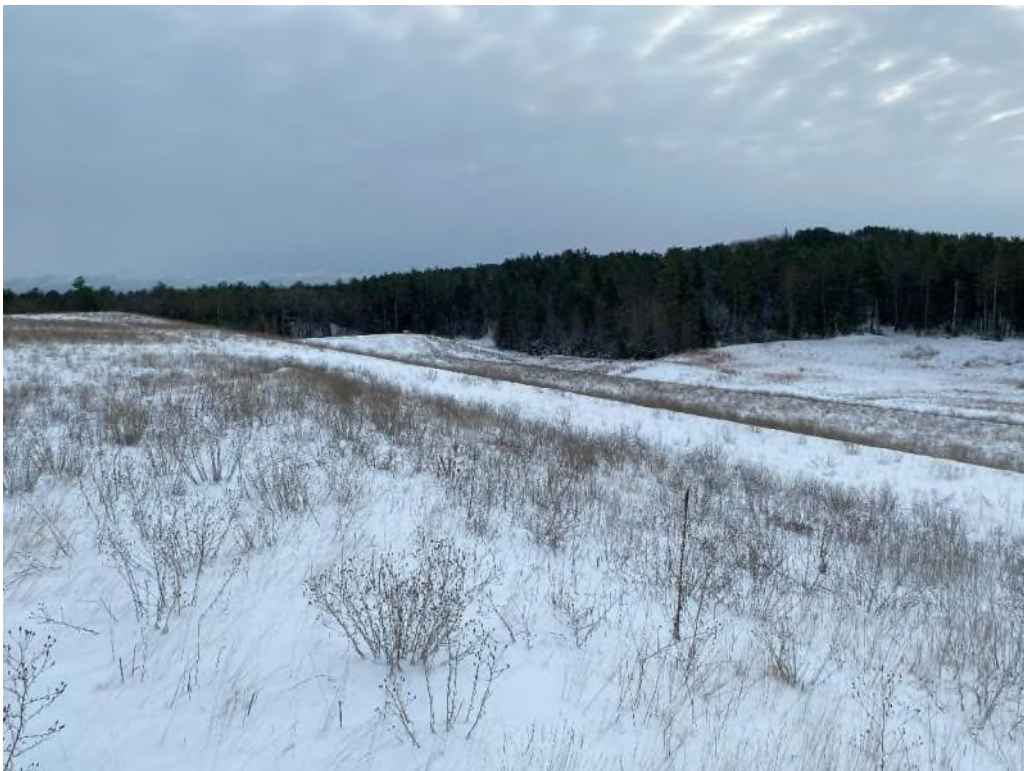
Photo No. 10 – Top of Landfill No. 3, looking southeast.

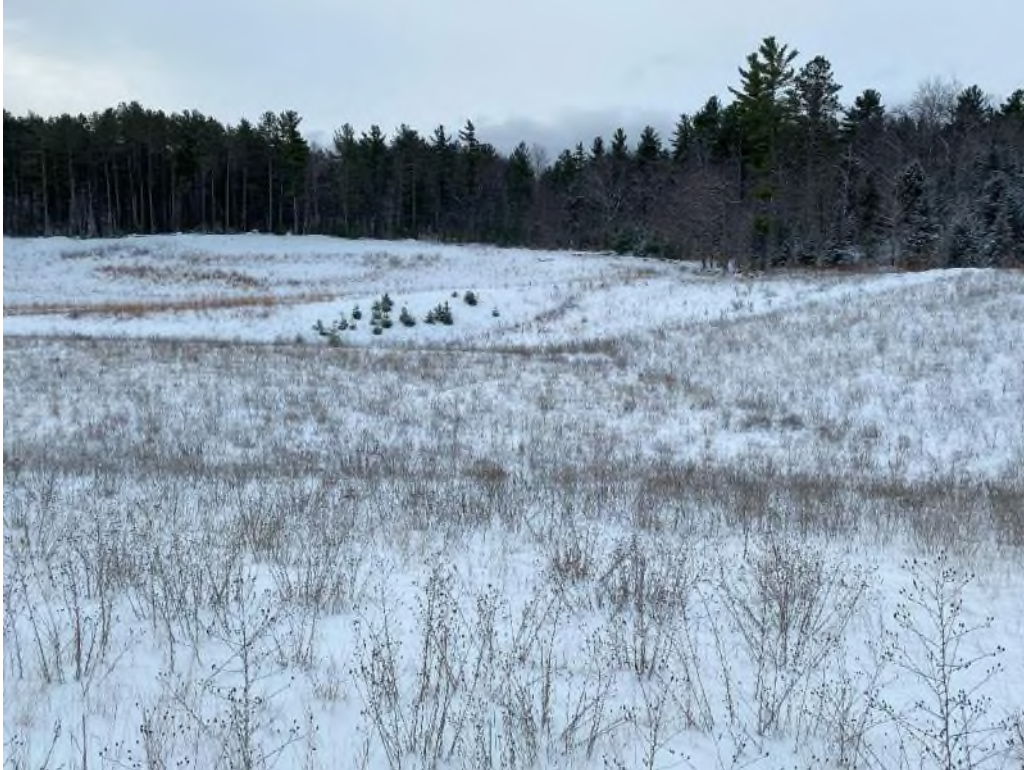
Photo No. 11 – South slope of Landfill No. 3, looking south.
