RE: WE ENERGIES CALEDONIA ASH LANDFILL
LICENSE #3232 - FID# 252108450
NR 506.20(3) 2024 ANNUAL CCR REPORT

2024 ANNUAL FUGITIVE DUST CONTROL REPORT **December 19, 2024**
CALEDONIA ASH LANDFILL

Re: 2024 Landfill Inspection Report
Caledonia Ash Landfill
We Energies
Town of Caledonia, Racine County, Wisconsin

2024 CCR ANNUAL GROUNDWATER MONITORING AND CORRECTIVE ACTION REPORT

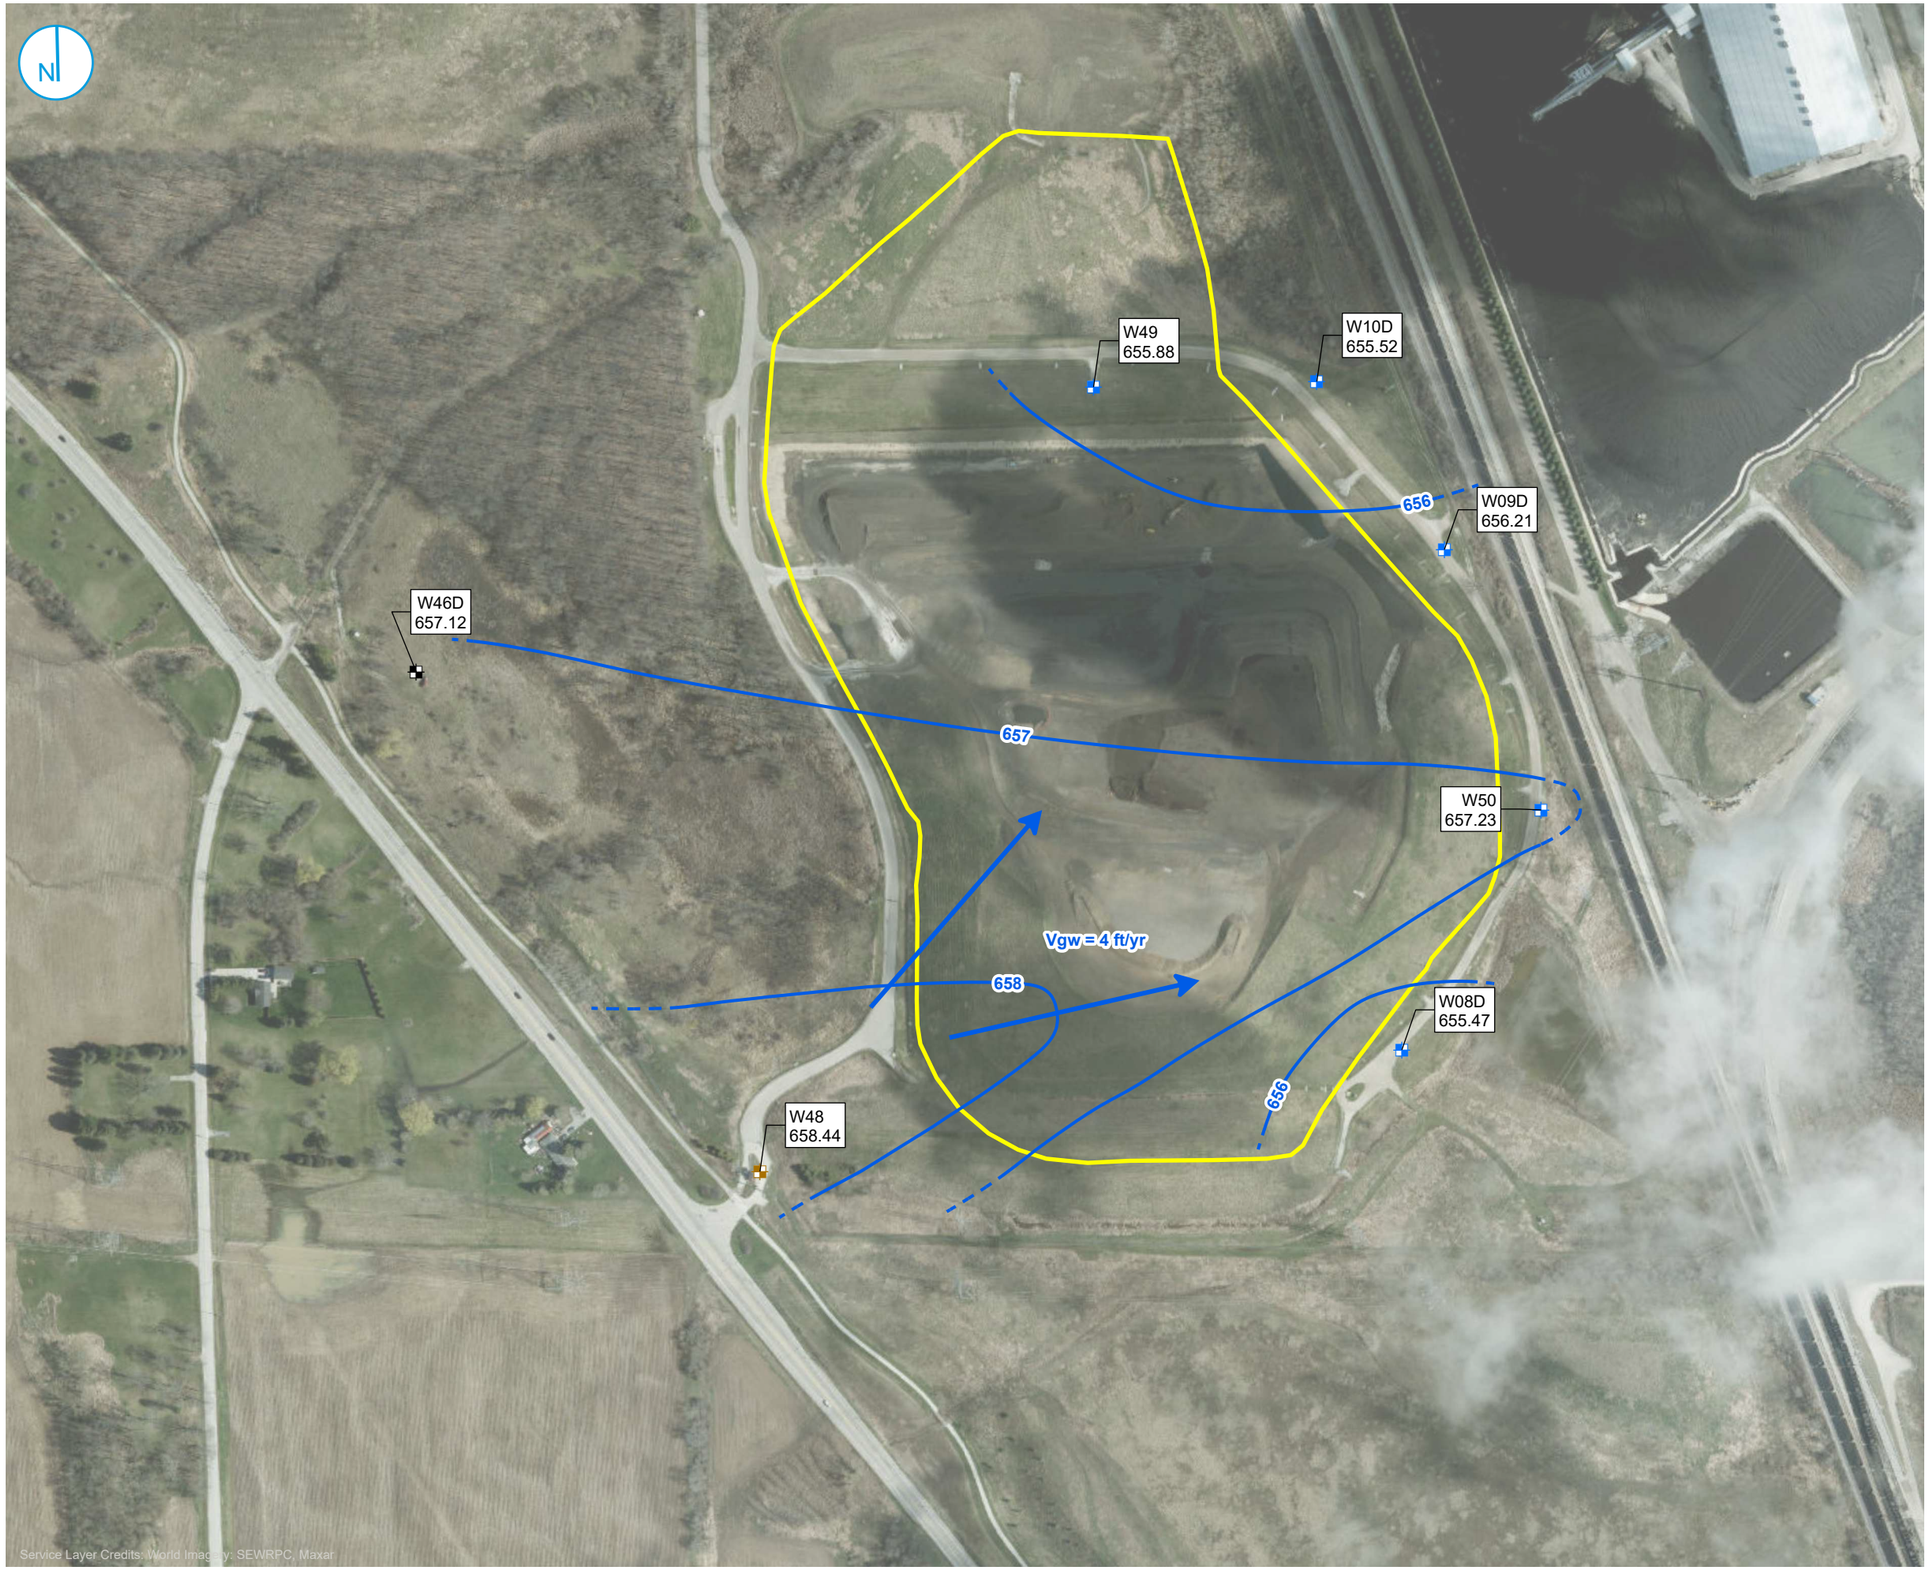
FIGURE 2

V = 4 feet/year
